M.Sc. Thesis
Master of Science in Civil Engineering

Study of Concrete Structures in Older Residential Buildings for Renovation Purposes

A Case Study Concerning Multistory Buildings in Greenland

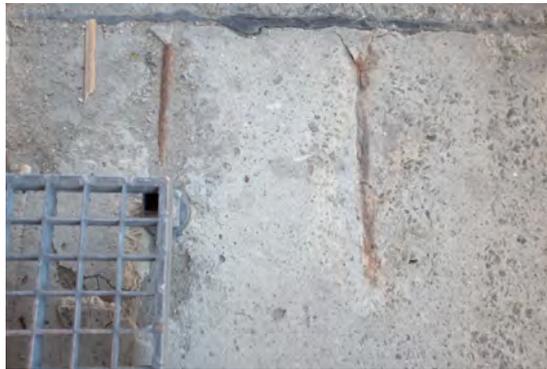
Reinforcement that is cast in concrete is protected against corrosion when the pH value of the concrete is very high. When carbonation occurs and the concrete pH becomes neutral the protective properties of the concrete ceases and therefore corrosion of the reinforcement can occur. Carbonation first occurs at the surface of the concrete and then slowly the carbonation depth will continue to increase as long as the concrete surface is in contact with atmospheric air. Typical signs of carbonation damage are large cracks and spalling of concrete, since the reinforcement volume expands when corrosion occurs [16]. Figure 2.12 shows a carbonation damage where the reinforcement has expanded due to corrosion and thereby the concrete cover layer has broken off.

Figure 2.12: Typical damage due to carbonation of the concrete.

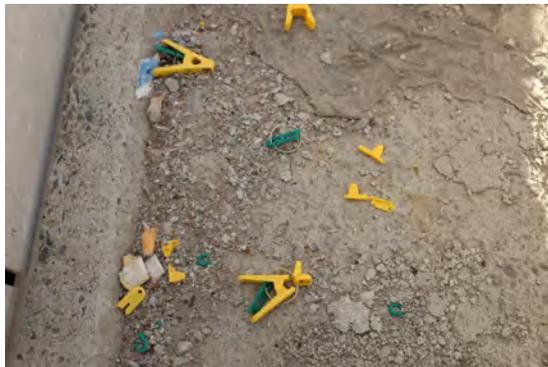
If concrete structures are exposed to cycles of freezing and thawing then damages can occur over time. The damages occur when water inside the concrete freezes, since it expands about 9%, and thereby a pressure larger than the tensile strength of the concrete can be produced. Freeze-thaw damage results in scaling, crumbling and cracking of the concrete surface. In relation to this the concrete cover layer will be reduced and thereby the reinforcement is more exposed. Freeze-thaw damages are usually avoided if the water/cement ratio is low and air entrainment is used [17]. An example of a freeze-thaw damage can be seen in Figure 2.13 where the concrete surface is crumbling.

Figure 2.13: Typical damage due to freeze-thaw cycles.

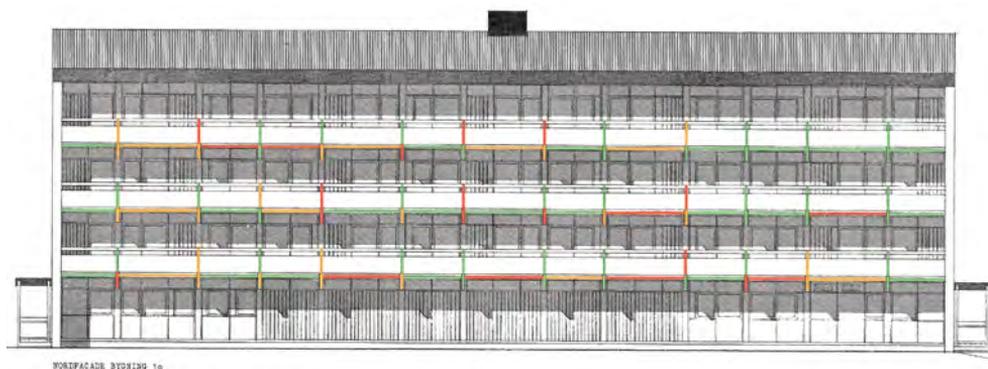
From a visual registration of block 10 damages on external concrete elements were registered and the registration can be found in Appendix B.1. The registered elements consisted of the top and bottom of the consoles as well as the balcony plates. The damage category for each element is illustrated in Figure 3.15 and 3.16, for the north and south facade respectively, where the categories have been given colors corresponding to the category. Category 1 with no severe damage is marked with green, category 2 with semi severe damage is marked with orange and category 3 with severe damage is marked with red.

Figure 3.15: Damage categories, north facade. Category A = green, category B = orange and category C = red.

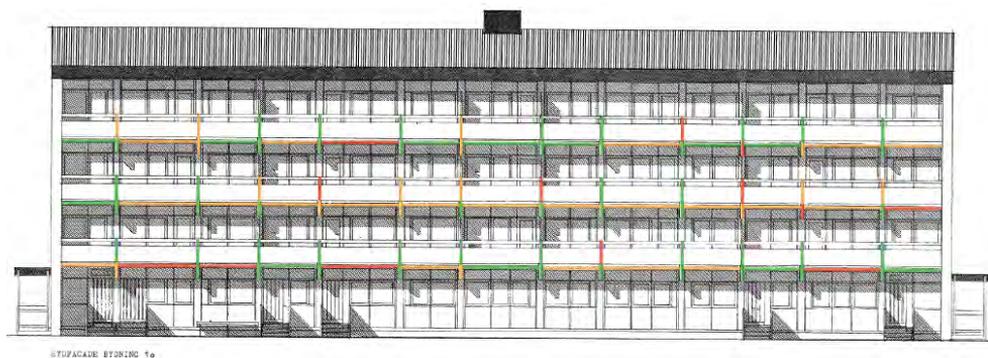
Figure 3.16: Damage categories, south facade. Category A = green, category B = orange and category C = red.

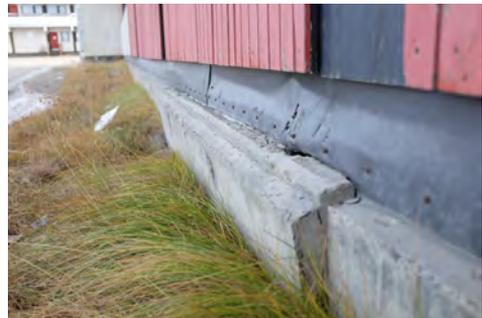
Figure 3.22: Displaced foundation beam.

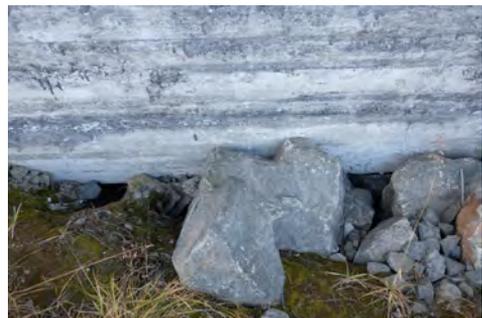
Figure 3.24: Hole under building filled with large rocks.

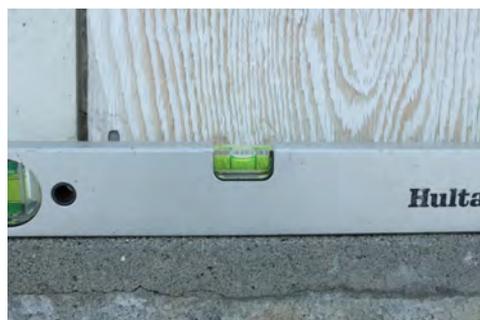
Block 10 is being demolished due to settlements, however no settlement damages were found. On the south side of the building a swampy area is located that most likely consist of permafrost clay and on the north side of the building rock appears approximately 20m away from the building. This highly suggests that the whole building is sinking towards south. A test was made with a spirit level in order to investigate whether the building was tilting or not. The spirit level was placed in many different places along the foundation, see Figure 3.25 and 3.26, in order to observe the angle of the building. In no location did the spirit level show any signs of displacement of the building, however the displacements might be so small that the spirit level could not record them.

Figure 3.26: Result from spirit level on foundation.

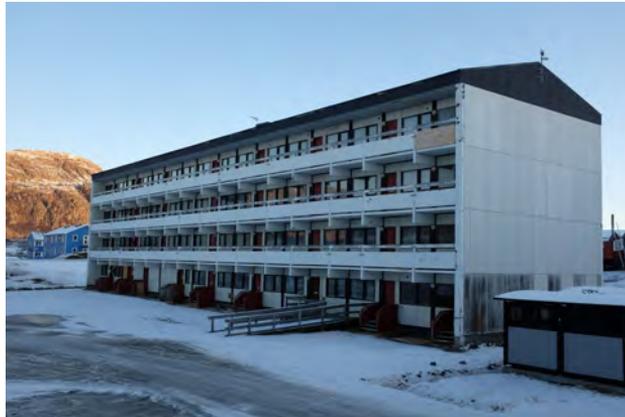
Block 7 was in October 2019 undergoing a renovation due to mold in 13 out of 21 apartments. It was therefore possible to get access to the building and a brief visual registration of the building was performed. Block 7 has four floors like block 10 and it consists of 16 modules which is 3 modules more than block 10. The facade with long consoles are placed towards west and the facade with short consoles are placed towards east. A picture of the building can be seen in Figure 3.29 and it can also be seen that one of the concrete railings have been covered with plywood to avoid falling concrete.

Figure 3.29: Block 7, Sisimiut.

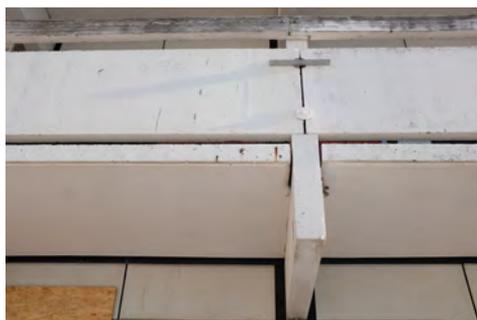
Figure 3.30: Visible reinforcement at edge of balcony plates.

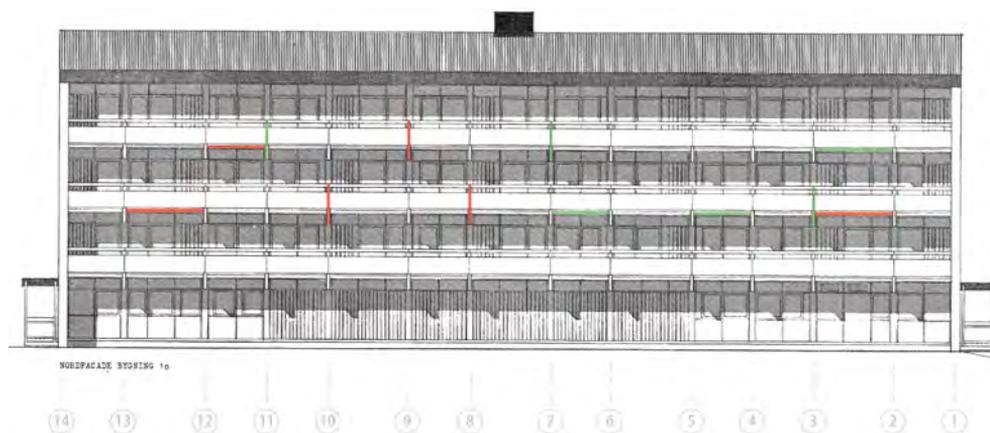
The chosen representative elements from the visual registration are illustrated in Figure 3.36, where the color green represents elements in a good condition and the color red represents elements in a bad condition. Pictures of all the tested elements are shown in Appendix A.3.

Figure 3.36: Tested elements, north facade. Good condition = green and bad condition = red.

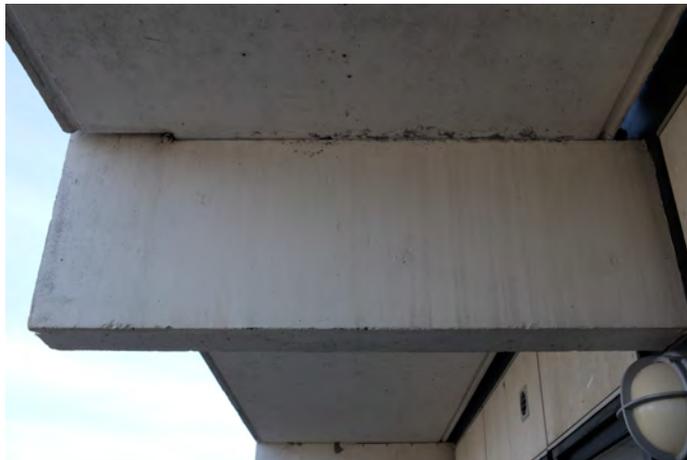
Figure A.1: Category 1. Smooth surface, intact console.
Console 2, level 2, bottom part.

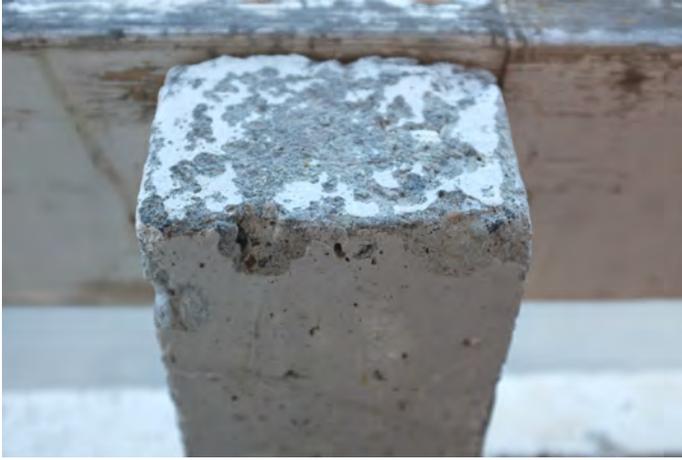
Figure A.2: Category 1. Slightly uneven top surface, no signs of cracks. Console 12, level 2, top part.

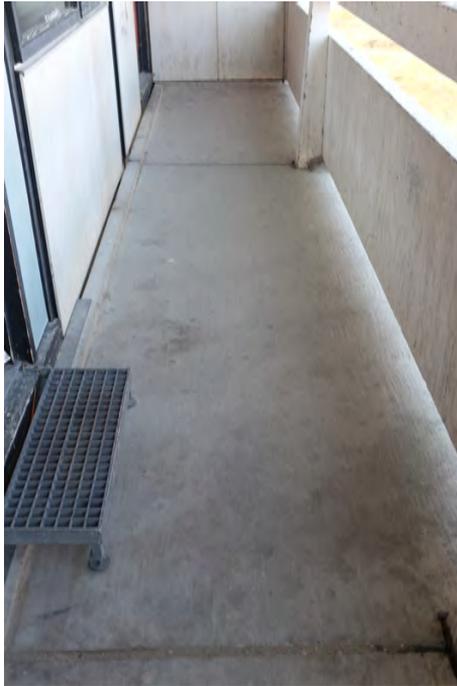
Figure A.3: Category 1. Smooth plate surface, no visible aggregates. Plate 2-3, level 3.

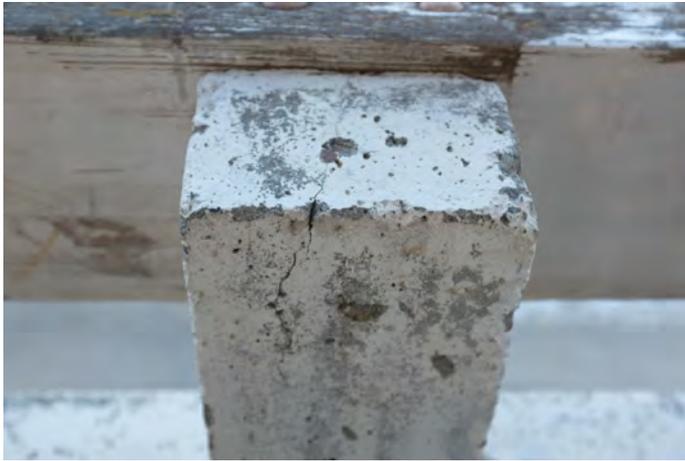
Figure A.4: Category 2. Small cracks. Console 11, level 2, top part.

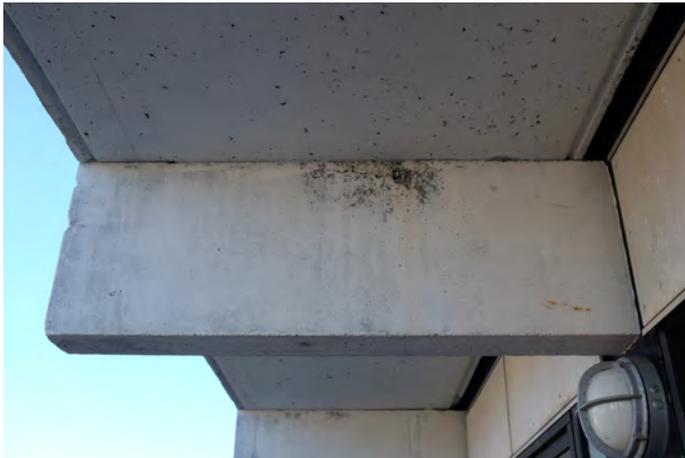
Figure A.5: Category 2. Uneven concrete surface patch, signs of cracks. Console 10, level 3, bottom part.

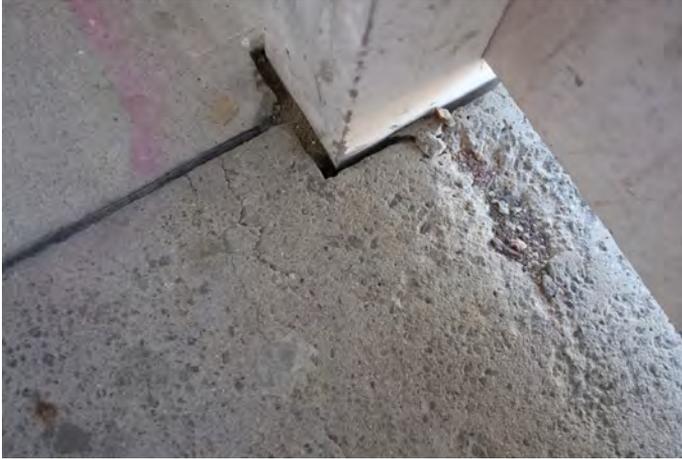
Figure A.6: Category 2. Spalling of concrete, loose concrete surface, small cracks. Plate 5-6, level 3.

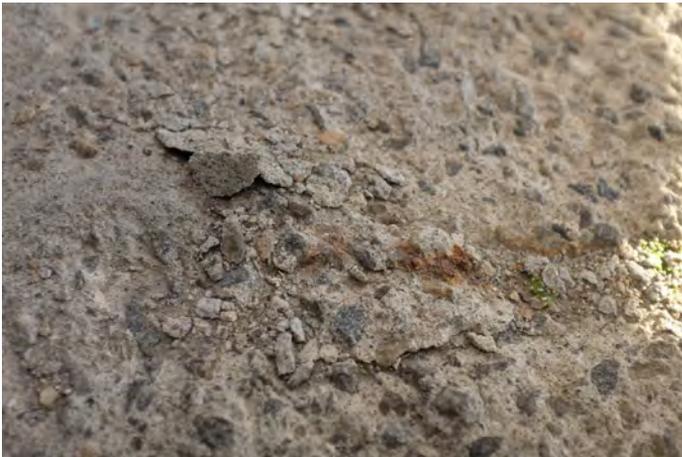
Figure A.7: Category 2. Loose/uneven concrete surface, visible aggregates. Plate 5-6, level 3, south.

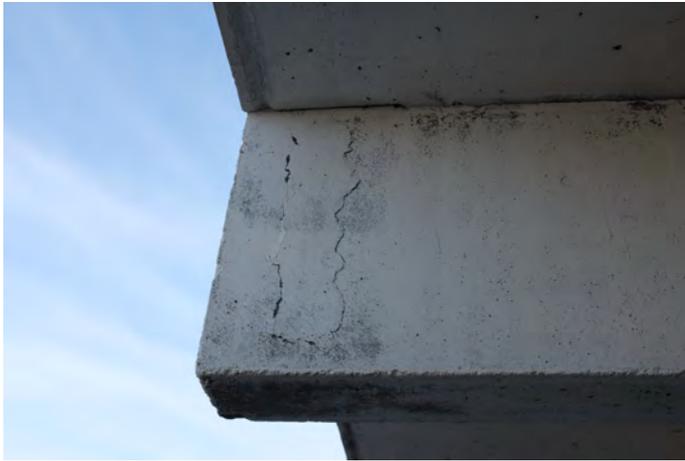
Figure A.8: Category 3. Large cracks, will lead to broken off concrete. Console 7, level 2, bottom part.

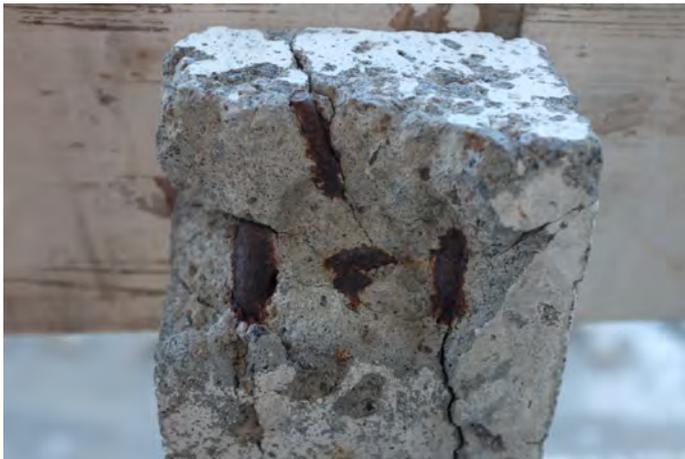
Figure A.9: Category 3. Large cracks, broken off concrete, visible reinforcement. Console 10, level 2, top part.

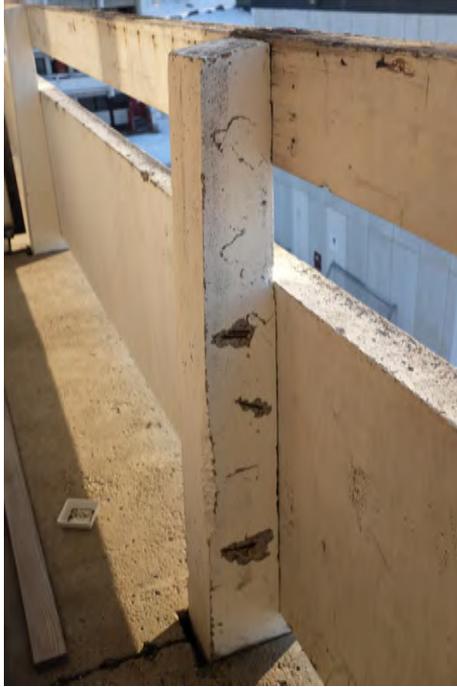
Figure A.10: Category 3. Spalling of concrete surface, visible reinforcement. Console 10, level 3, south, top part.

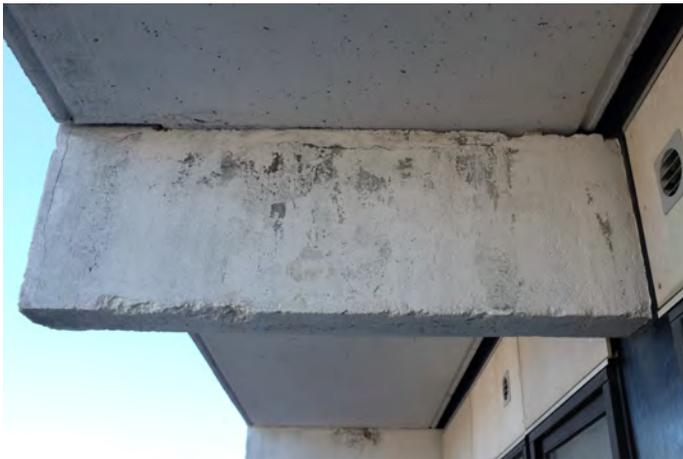
Figure A.11: Category 3. Large cracks, uneven concrete surface. Console 9, level 3, bottom part.

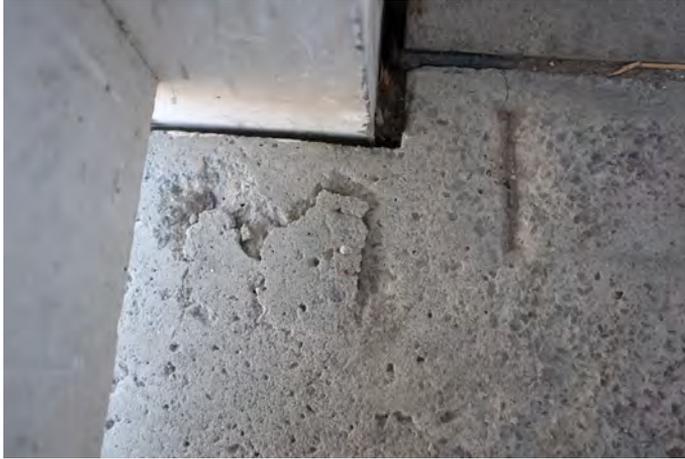
Figure A.12: Category 3. Loose concrete surface, visible reinforcement. Plate 3-4, level 1.

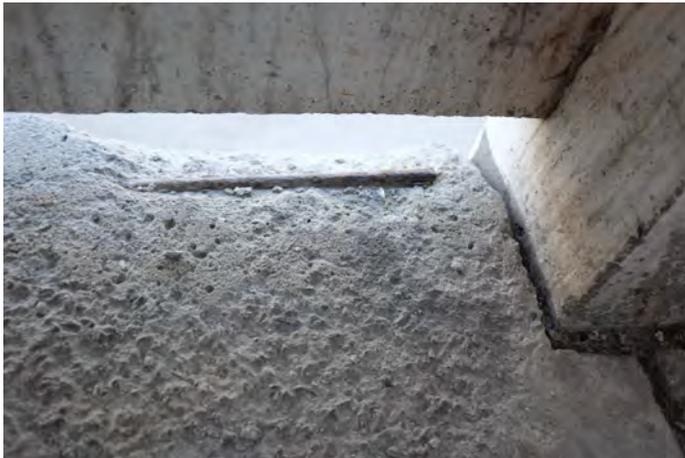
Figure A.13: Category 3. Broken off concrete, visible reinforcement. Plate 9-10, level 1.

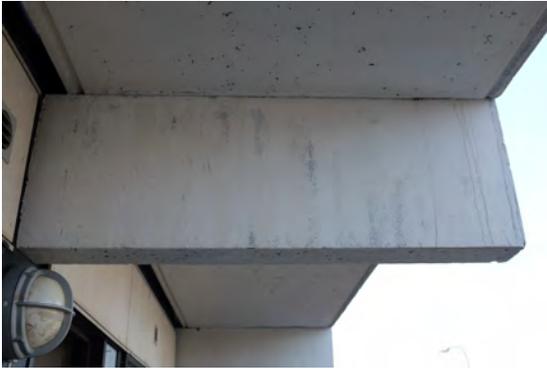
Figure A.18: Console 3, level 2, bottom part, good condition.

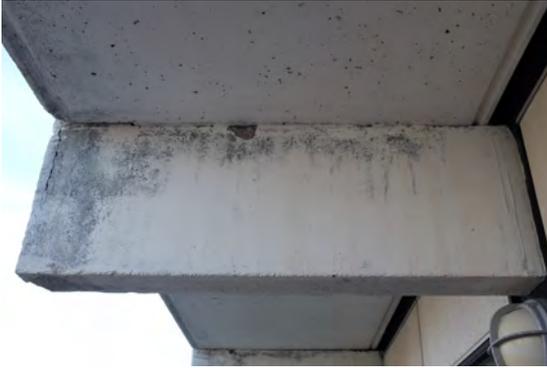
Figure A.20: Console 8, level 2, bottom part, bad condition.

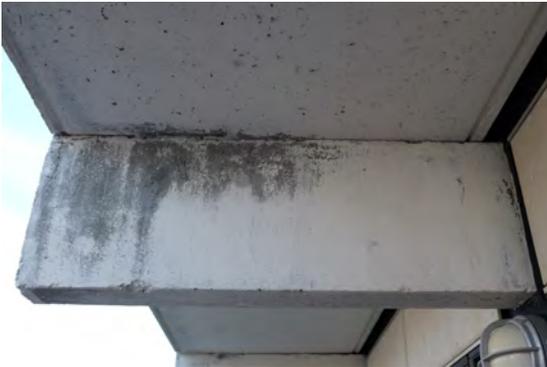
Figure A.22: Console 10, level 2, bottom part, bad condition.

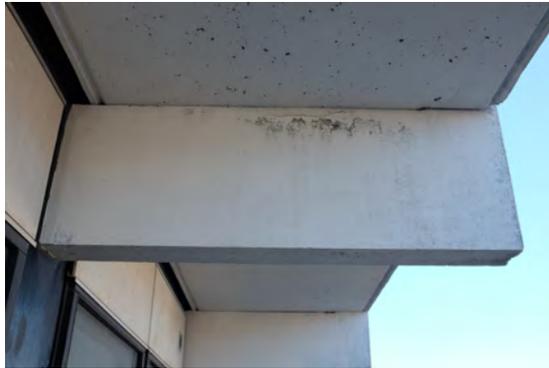
Figure A.24: Console 7, level 3, bottom part, good condition.

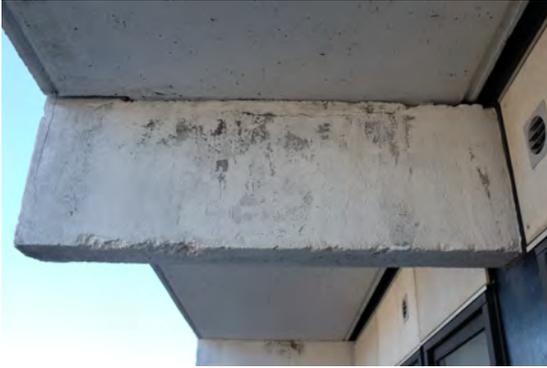
Figure A.26: Console 9, level 3, bottom part, bad condition.

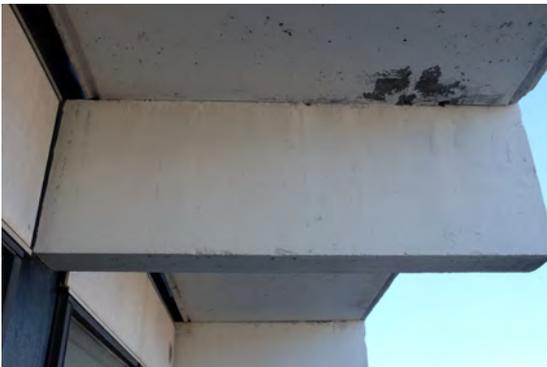
Figure A.28: Console 11, level 3, bottom part, good condition.

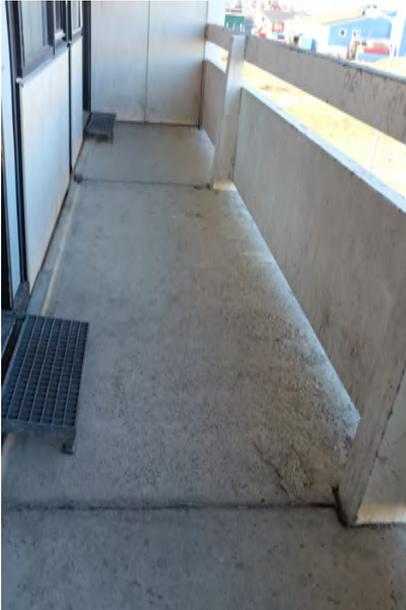
Figure A.30: Plate 2-3, level 2, bad condition.

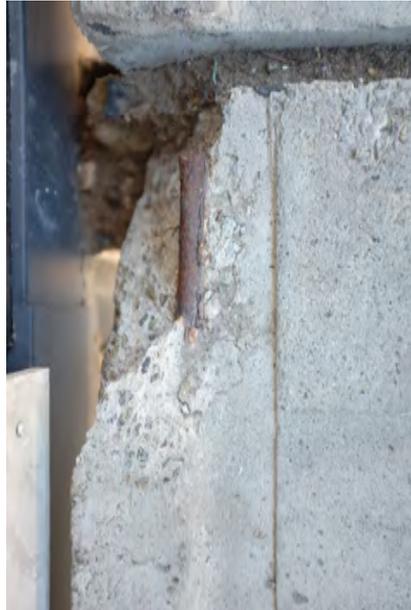
Figure A.31: Plate 2-3, level 2, damage.

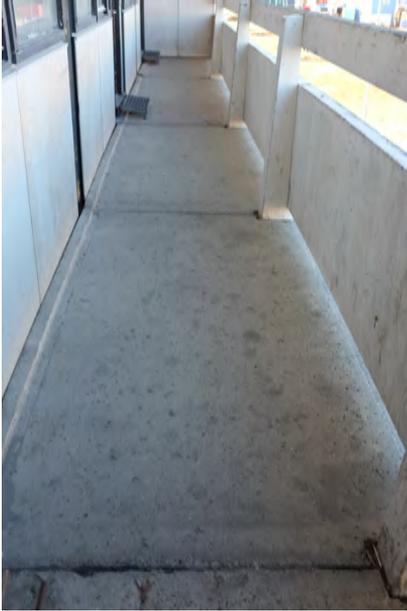
Figure A.32: Plate 4-5, level 2, good condition.

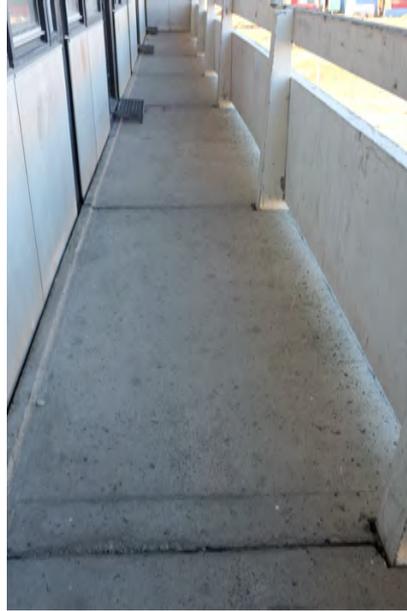
Figure A.33: Plate 6-7, level 2, good condition.

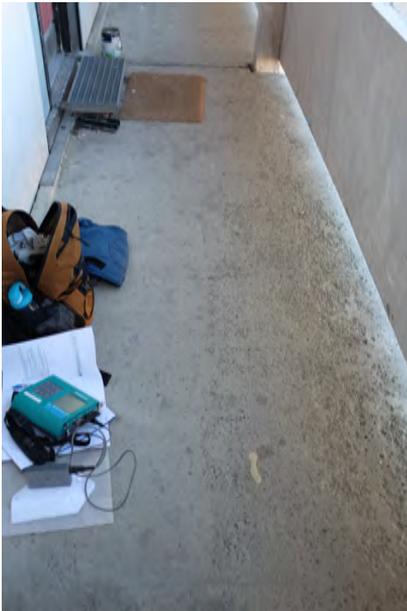
Figure A.34: Plate 12-13, level 2, bad condition.

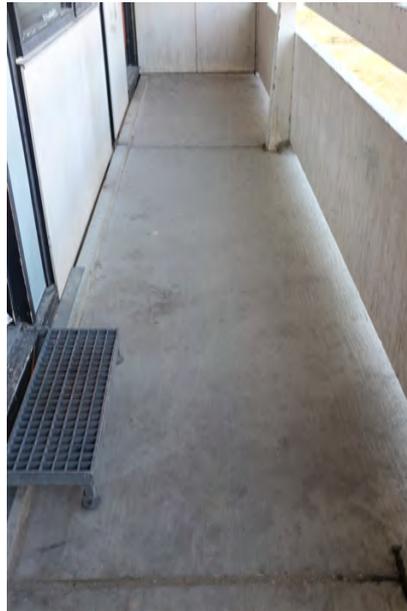
Figure A.35: Plate 2-3, level 3, good condition.

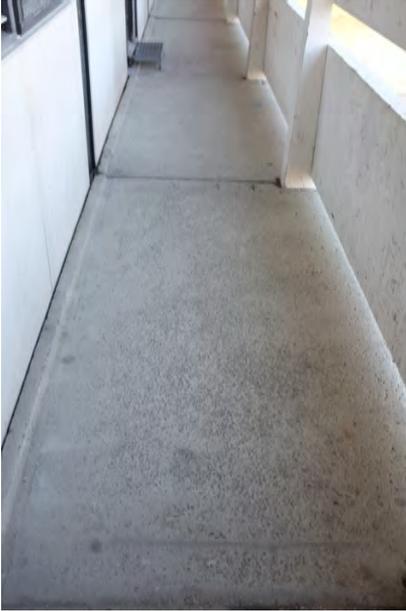
Figure A.36: Plate 11-12, level 3, bad condition.

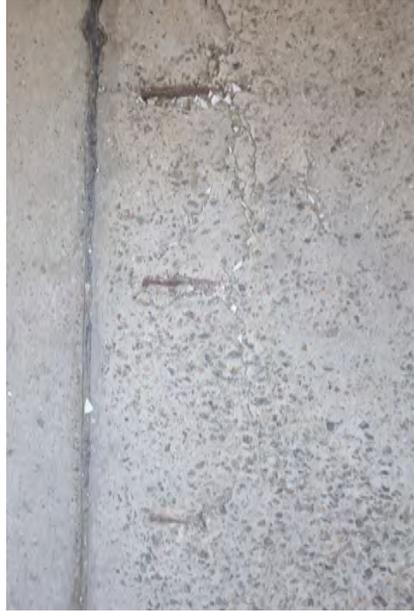
Figure A.37: Plate 11-12, level 3, damage.
