M.Sc. Thesis
Master of Science in Civil Engineering

Study of Concrete Structures in Older Residential Buildings for Renovation Purposes

A Case Study Concerning Multistory Buildings in Greenland

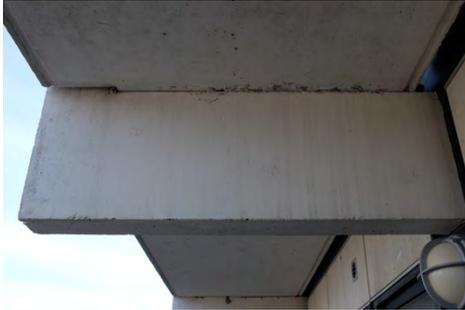
(a) Damage category 1, console bottom. Smooth surface, intact console.

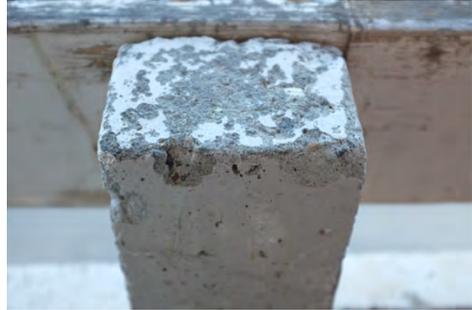
(b) Damage category 1, console top. Slightly uneven top surface, no signs of cracks.

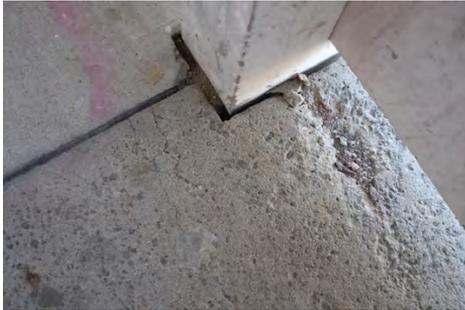
(c) Damage category 2, plate. Spalling of concrete, loose concrete surface, small cracks.

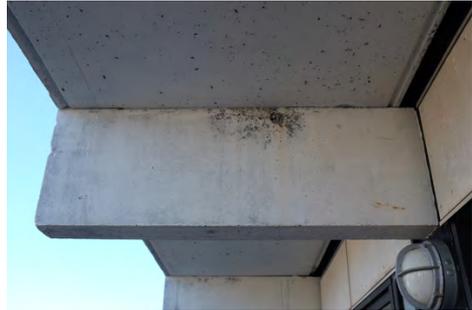
(d) Damage category 2, console bottom. Uneven concrete surface patch, signs of cracks.

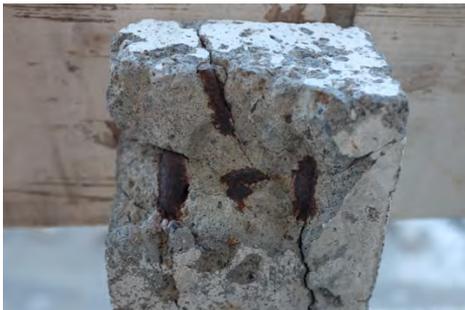
(e) Damage category 3, console top. Large cracks, broken off concrete, visible reinforcement.

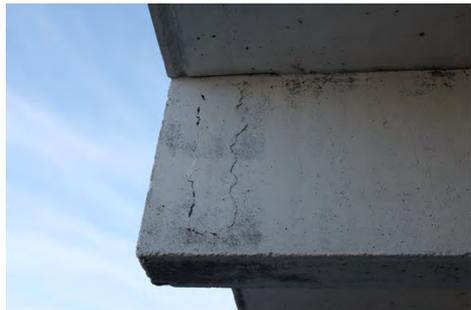
(f) Damage category 3, console bottom. Large cracks, will lead to broken off concrete.

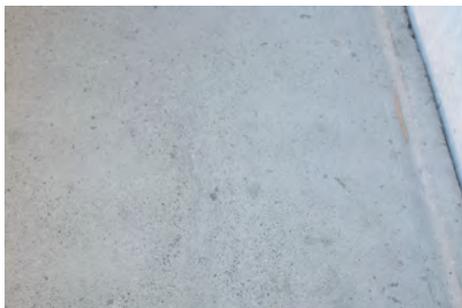
Figure 3.17: Even concrete surface.

are caused by freeze-thaw damage. Photos of an even and uneven concrete surface are shown in Figure 3.17 and 3.18.

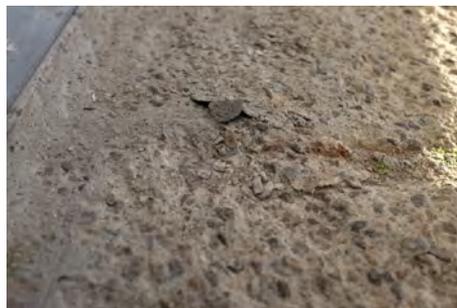
Figure 3.18: Uneven concrete surface.

For the plates on the south facade 54% of them belong to damage category 2 and this number stands out. The balcony plates have an uneven concrete surface where scaling of the concrete has occurred. It is very likely that the loose concrete surfaces

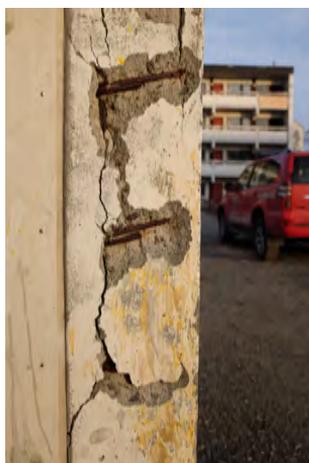
Figure 3.19: Damages on column.

The damage which can be seen in Figure 3.19 is a typical carbonation damage where the concrete is cracked and broken off due to corrosion of the reinforcement. In general the columns of block 10 only have few damages on each column and images of all the gable columns are given in Appendix A.2. The damages on the gable columns of the other non-renovated blocks in Sisimiut were in a worse condition compared to block 10. Large amounts of concrete has broken off which makes the reinforcement

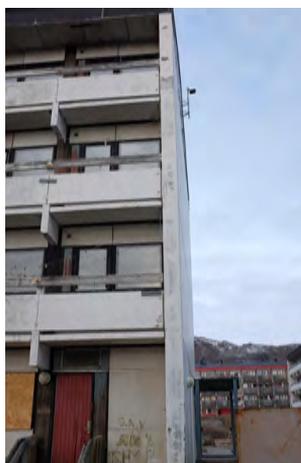
Figure 3.20: Gable column south-east.

An example of a damage on a gable column is given in Figure 3.19. The damage is placed on the gable column towards south-east which is shown in Figure 3.20.

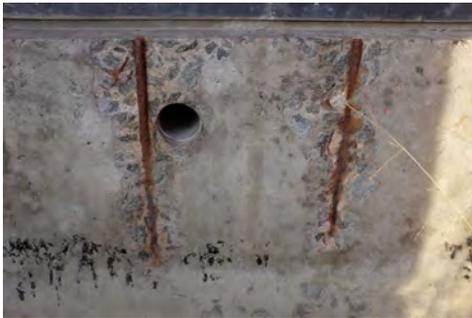
The foundation of block 10 consists of prefabricated beam elements. The beam elements placed along the edges of the building are not in a good condition and corroded reinforcement is visible on most of the elements, see Figure 3.21. The beams have over time been displaced and some of the beams are so displaced that they are not supporting the building anymore as seen in Figure 3.22. The bearing foundation is not visible and the condition is unknown. However due to soil displacement large holes under the building can be found and it is possible to see the bearing piles in some places, see Figure 3.23. The holes have been filled with large rocks as in Figure 3.24.

Figure 3.21: Corroded reinforcement along the foundation.

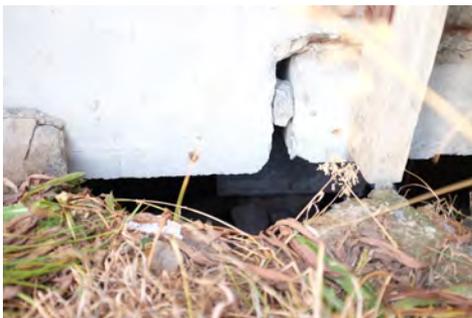
Figure 3.23: View of bearing pile under building.

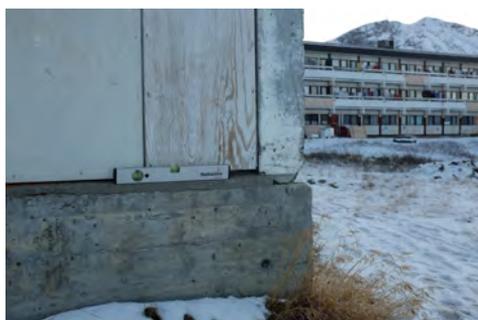
Block 10 is being demolished due to settlements, however no settlement damages were found. On the south side of the building a swampy area is located that most likely consist of permafrost clay and on the north side of the building rock appears approximately 20m away from the building. This highly suggests that the whole building is sinking towards south. A test was made with a spirit level in order to investigate whether the building was tilting or not. The spirit level was placed in many different places along the foundation, see Figure 3.25 and 3.26, in order to observe the angle of the building. In no location did the spirit level show any signs of displacement of the building, however the displacements might be so small that the spirit level could not record them.

Figure 3.25: Placement of spirit level on the foundation.

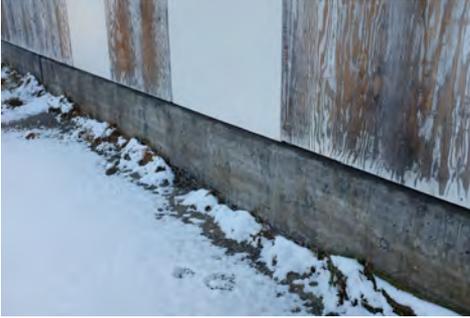
Block 10 is the only block in Sisimiut which has a prefabricated foundation, the rest of the blocks have in-situ cast foundations with no visible reinforcement. A picture of the foundation of block 7 is shown in Figure 3.27, the foundation is in a good condition and it is in-situ cast. Many of the blocks are surrounded by rock which most likely means that the foundations are placed directly on rock, which creates a much more stable foundation. Block 11 in Sisimiut has a foundation built on rock, which means that the bottom level of the building is not continuous, see Figure 3.28.

Figure 3.27: In-situ cast foundation of block 7.

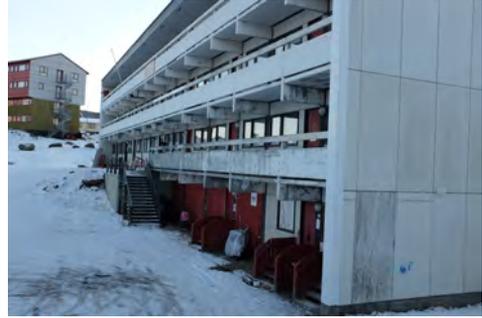
Figure 3.28: Solid rock foundation of block 11.

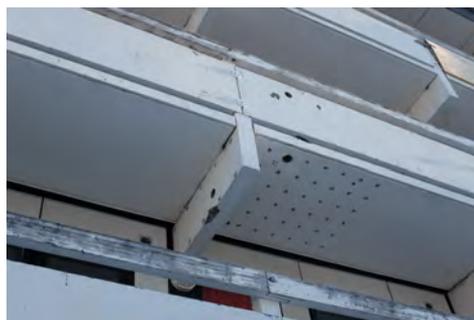
in percentage for each of the two facades (west and east) are given in Table 3.4. The elements were checked for damages such as visible reinforcement and broken off concrete, and in general the percentages are very low. For the plates the percentage of visible reinforcement is very high and the reason could be that the transverse reinforcement have been placed too close to the edge of the plates when they were cast. This results in visible reinforcement along the edge of the plates as seen in Figure 3.30. Block 7 had previously been tested by drilling out cores from the concrete elements, see Figure 3.31. The holes had not been filled out after the testing and it was noticed that the reinforcement inside the holes have corroded.

Figure 3.31: Holes in the elements due to previous drill core testing.

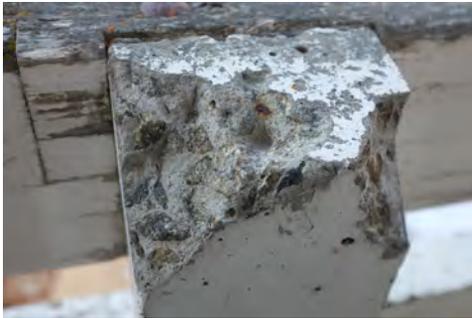
In general the condition of block 7 is much better than the condition of block 10. The main difference seems to be the type of concrete used, since in block 7 all of the concrete surfaces are smooth and hard. The amount and size of the aggregates are also larger compared to block 10, see Figure 3.32 and 3.33.

Figure 3.32: Aggregates in concrete, block 7.

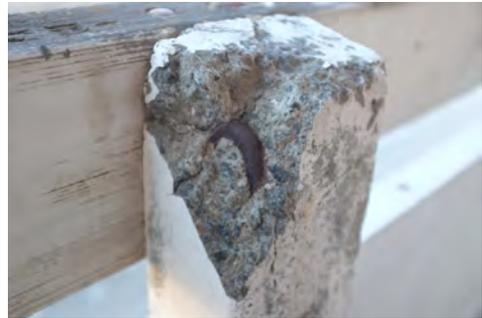
Figure 3.33: Aggregates in concrete, block 10.

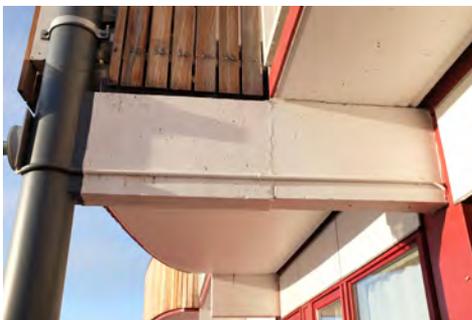
The condition of the renovated blocks in Sisimiut is not known. The blocks showed no visible signs of damage and this could be because the condition of the elements is very good or because the damages were hidden. The renovation method is unknown and therefore it is not known whether damaged elements have been fully or superficially renovated. Figure 3.34 shows the elongation of a console. It can be seen that the connection is skew and it is unknown how the elongation of the console had been made. The elongated console is supported by a column and therefore the skew connection might not have an effect on the bearing capacity of the console. Figure 3.35 shows a facade with long consoles and no damages can be seen on any of the consoles or plates.

Figure 3.34: Renovated block, elongation of console.

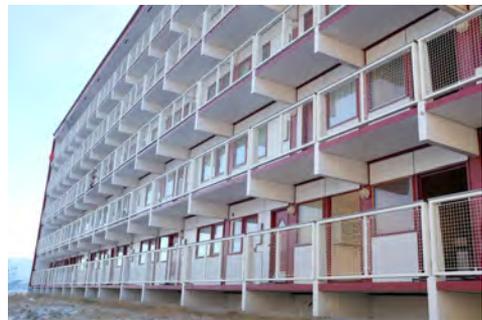
Figure 3.35: Renovated block, facade with long consoles.

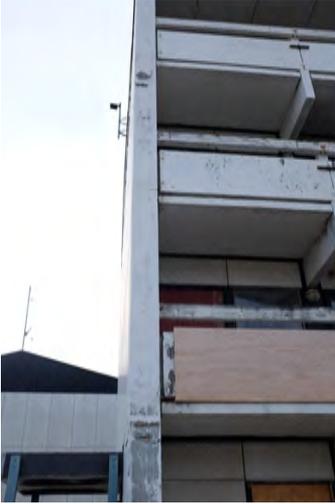
Figure A.14: Gable column north-east.

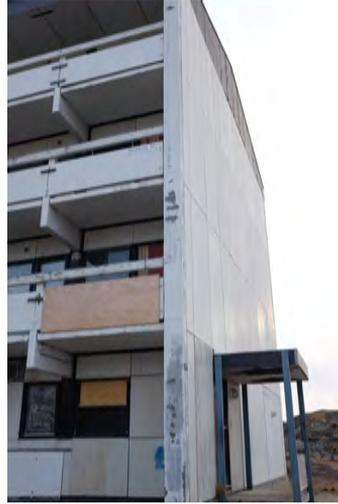
Figure A.15: Gable column north-west.

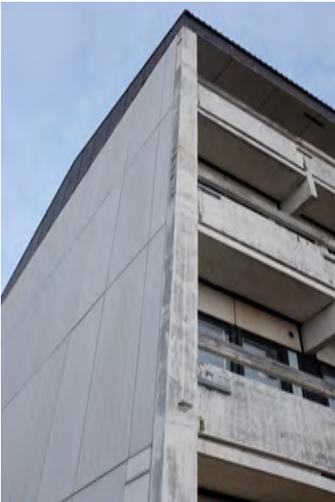
Figure A.16: Gable column south-west.

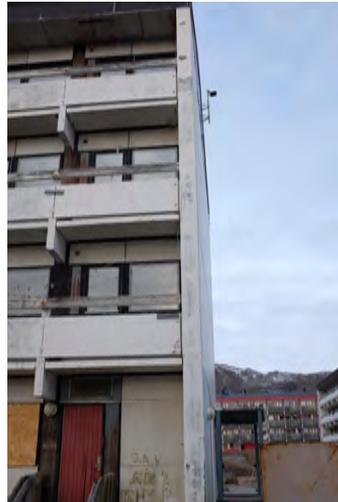
Figure A.17: Gable column south-east.

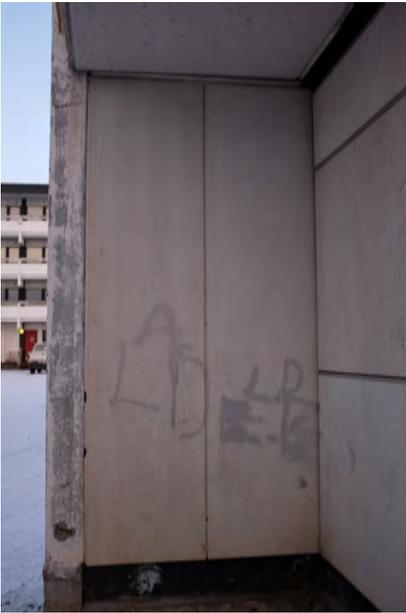
Figure A.39: Gable column, level 0.

The gable columns were investigated in the condition assessment, however no analysis of the bearing capacity has been performed. The columns are very damaged and therefore it would not make sense to perform calculations of the columns, since the bearing capacity would be individual for each column. It is assumed that the columns, despite the damages, will not effect the overall stability of the building since the gable walls are massively built and the condition of the walls is good. For a renovation it is recommended to repair the columns and prevent further carbonation of the concrete.
